Home Inspection Report

Inspection Date:
June 6, 2017

Prepared by:
**Enlightened Home
Inspections, LLC
16292 High Canal Ct.
Broomfield, CO 80023**

Report Number:
2017060601

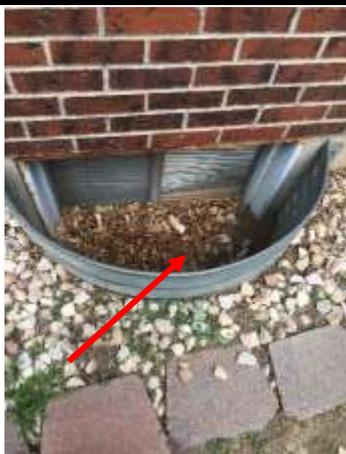
#1

One or more window wells on the exterior of the dwelling were placed in a walkway or patio (**See inspection photo #1**). As a safety precaution, grills are required to cover these wells to prevent accidental falls into them. We recommend installation of adequate grills wherever necessary to comply with current industry standards.

5. One or more window wells on the exterior of the dwelling were placed in a walkway or patio. As a safety precaution, grills are required to cover these wells to prevent accidental falls into them. We recommend installation of adequate grills wherever necessary to comply with current industry standards.
